**TILE ROOF SYSTEMS;
ANALYSIS AND INSPECTION TECHNIQUES FOR ROOF CONSULTANTS**

Robert L. Fulmer

Roof Consultants Institute
20th International Convention and Trade Show
Miami, Florida

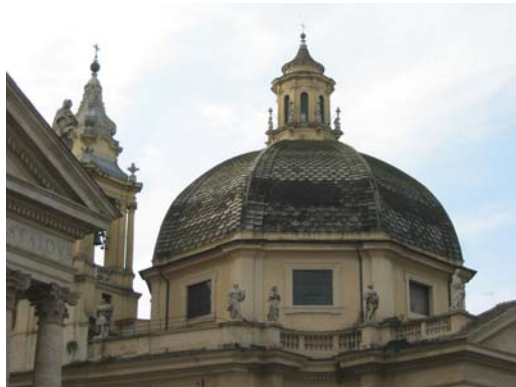
Flat clay tile on a dome at the Pantheon, Rome, Italy.
Photo courtesy of the author.

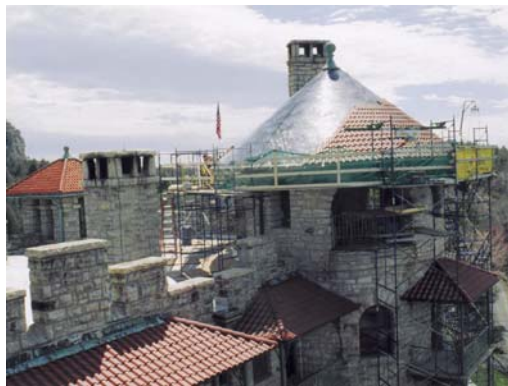
Process of replacing original Ludowici Celadon clay Spanish tile (initially installed at the turn of the 20th century) with new tile by the same manufacturer on a historic hotel in upstate New York (the original tile came from Celadon’s plant in Alfred, NY).

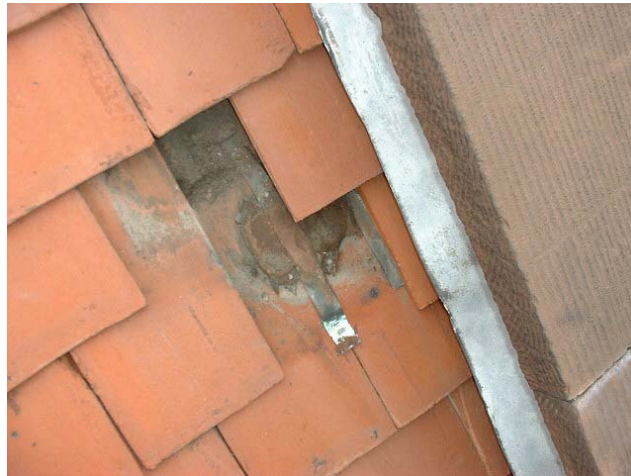
Clay overlapping (flat shingle) tile exhibiting signs of water absorption.
Photo courtesy of the author.

As with most forensic roof investigations, the inspection begins by accessing the roof in order to evaluate its components. Again we need to answer the questions, what type of tile is it? What point has the system reached within its’ service life? Are there problems and if so are they normally occurring, the result of environmental factors or pre-mature failure. One of the more common misunderstandings about tiles is how various systems age. For the most part, this is a direct result of the hardness of the tile. Both concrete and clay tile are porous in varying degrees. It is porosity and the resulting water absorption that weakens the tile over time. Water saturation in concrete tile

increases over the life of the tile, accelerated by erosion of the cement and exposure of the mix aggregate. Toward the end of the concrete tile's service life, efflorescence can form on the underside of the tile prior to complete saturation. After saturation, water then drips off of the underside of the tile. In the latter portion of this process, most concrete tiles are too soft to walk on. Clay tile exhibit different characteristics toward the end of their service life. Clay tile also absorb water, however their porosity is a function of the density of the clay used in their manufacture and the vitrification process. Vitrification is the process that turns clay to glass by applying heat (firing). Clay tile that are not thoroughly vitrified are softer and consequently possess a shorter service life. Freeze/thaw cycles in colder climates cause spalling when moisture expands as it freezes. Spalling and flaking are the result of normal water absorption and wear process. Flaking begins on the surface of the tile and continues throughout the life of the tile until the flaking wears completely through. The presence of these elements are sometimes incorrectly diagnosed as tile failure. During examination of a representative number of tiles, the flaking should be dislodged. If algae or lichen are present under the flaking, the process is a slow, natural one. If bright, clean clay is exposed, the process is accelerated and newer. This could be the result of environmental factors i.e.; hail damage, excessive hot and cold temperature variation, or it could indicate premature tile failure.

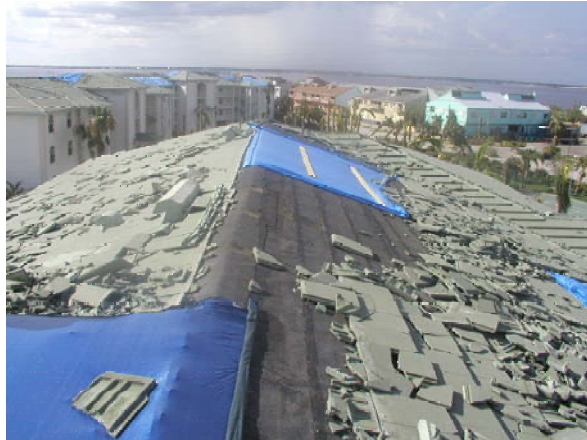
Example of a ridge tile failure in a concrete tile roof system.
Photo courtesy of Mr. Warren French of French Engineering, Inc.

from heavy to moderate. Virtually all of the tile encountered was concrete with only one clay tile roof examined. Of particular interest was how the various attachment methods of the tile performed in such a severe wind event. Because Punta Gorda is an older community, most tile roofs were older, mortar set concrete tile. Overall, system performances of the older mortar set tiles were the poorest. Mortar deterioration and subsequent loss of adhesion resulted in either substantial numbers of tile blown from the roof deck, to completely missing rakes and ridges.

Failure of the ridge tile occurred on roofs that did not use a ridge nailer board but relied on mortar without fasteners.

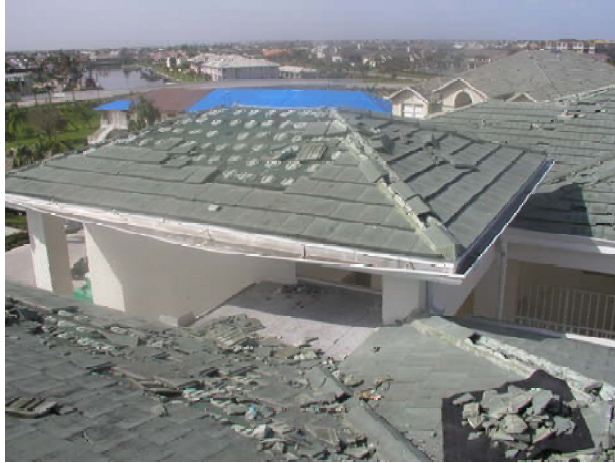
Upper concrete tile roof exhibiting partial failure of the “foam set” system possibly due to an improper foam mix. Lower roof exhibiting damage from flying debris.
Photo courtesy of Mr. Warren French of French Engineering, Inc.

The second failure source was an installation error occurring when the two part foam mix was improperly mixed, resulting in the foam being either “part A rich” or “part B rich”.
